**Severely deteriorated culvert
structurally rehabilitated
with the CIPP
Poly-Triplex® Liner System.**

Brighton, CO

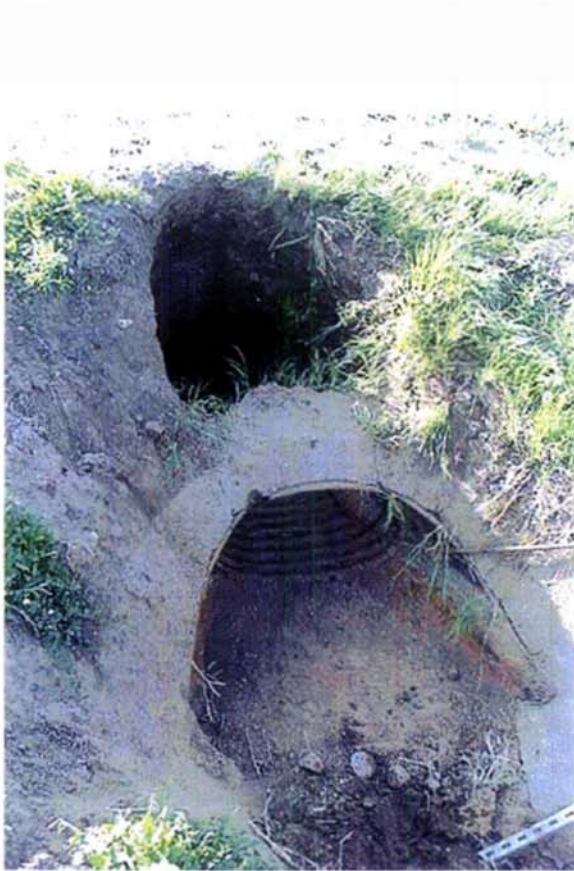
Corrugated Culvert Pipe with serious structural deterioration prior to lining.
